Your Home Inspection Report

1234 Your St
Home Town, IL 60000

Prepared by: Martin Home Inspection Services, Inc.
15460 Wildwood Ct.
Libertyville, IL 60048
www.martinspect.com

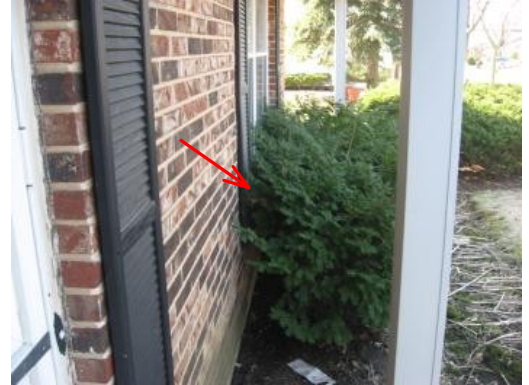
Acceptable Driveway: Asphalt
Acceptable Walks: Concrete: Typical cracks and settling present, monitor for movement.
Acceptable Steps/Stoops: Concrete
Acceptable Patio: Paver
Acceptable Deck: Treated wood
Acceptable Grading: Moderate slope
Acceptable Swale: Adequate slope and depth for drainage
Marginal Vegetation: Landscaped: [Cut all vegetation back 6" from house.](#)

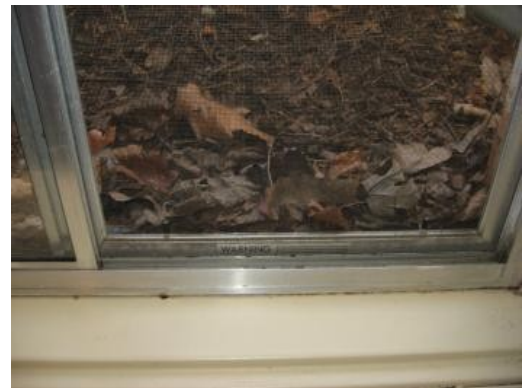
Marginal Window Wells: Drain present: [Clean out all debris to allow proper drainage.](#)

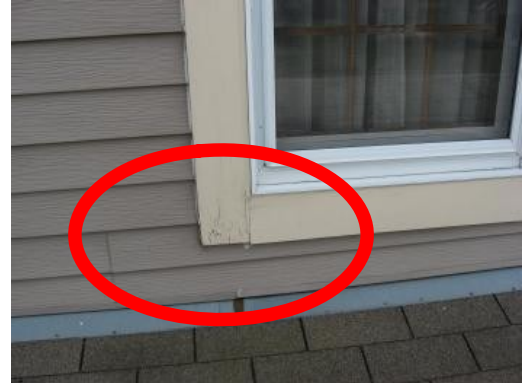
Acceptable Type: Combination of brick and wood siding
Marginal Trim: Wood: **Recommend fresh paint and caulk.**

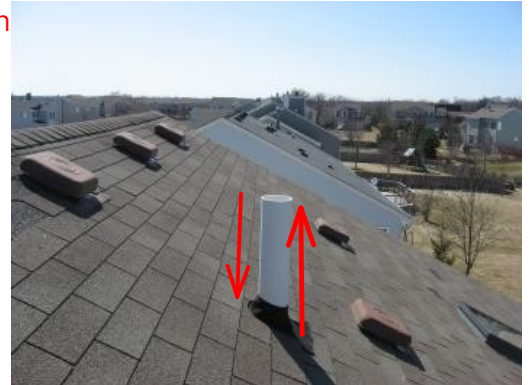
Defective Plumbing Vents: PVC: **Plumbing vent extends more than 12" above roof surface, needs repair.**

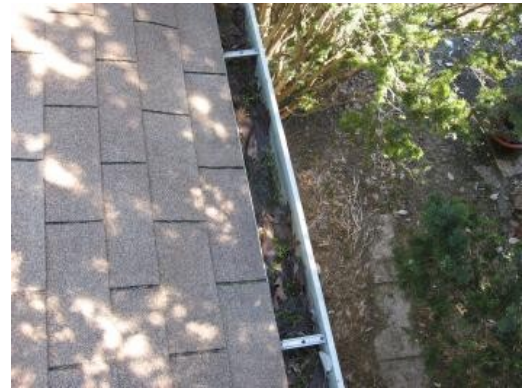
Gutters: Aluminum: **Recommend cleaning to allow proper drainage.**

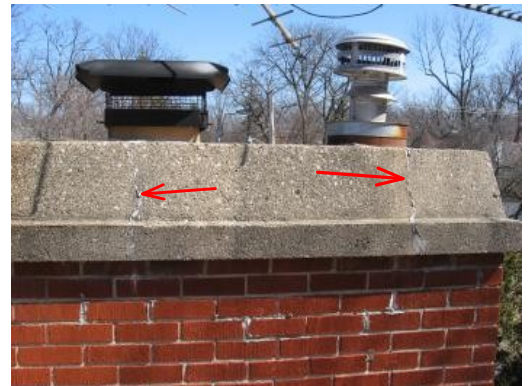
Flue/Flue Cap: Clay flue with cement cap:
Typical crack present on chimney,
monitor for leaks.

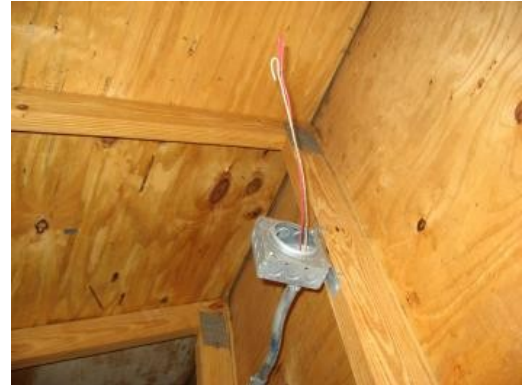
Acceptable	Unable to Inspect: 15%
Acceptable	Roof Framing: 2x4 Truss
Acceptable	Sheathing: OSB
Acceptable	Ventilation: Roof and soffit vents
Acceptable	Insulation: Combination of batts and loose
Acceptable	Insulation Depth: 12"
Acceptable	Vapor Barrier: Paper
Not Present	Attic Fan:
Not Present	House Fan:
Defective	Wiring/Lighting: 110 VAC: Open junction boxes, needs repair.

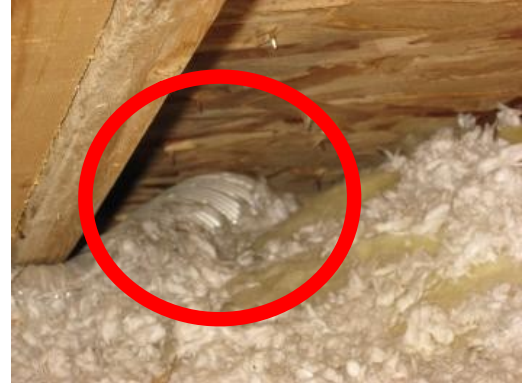
Bathroom Fan Venting: Vented in soffit:
Recommend venting bath fans to exterior to prevent any
moisture related problems.

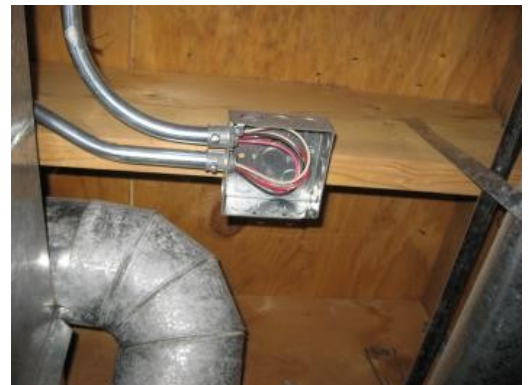
Acceptable Unable to Inspect: 10%
Acceptable Ceiling: Exposed framing
Acceptable Walls: Concrete
Acceptable Floor: Concrete
Acceptable Floor Drain: Surface drain
Acceptable Doors: Solid wood
Acceptable Windows: Aluminum slider
Defective Electrical: 110 VAC outlets and lighting
 circuits: Electrical boxes missing covers, needs
 repair.

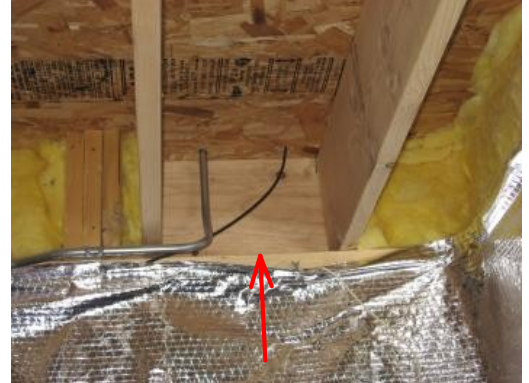
Insulation: Batting: **Insulation missing in multiple areas of exterior joist band, recommend repair.**

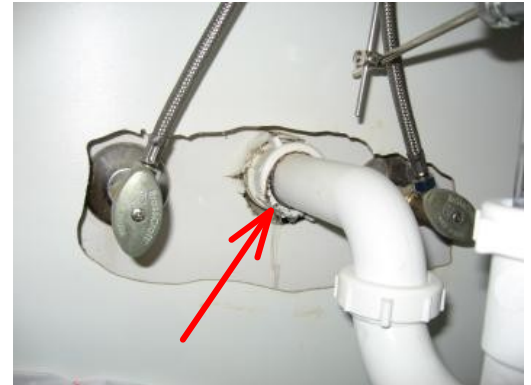
Acceptable Closet: Single
Acceptable Ceiling: Painted Drywall
Acceptable Walls: Painted Drywall
Acceptable Floor: Carpet
Acceptable Doors: Solid wood
Acceptable Windows: Vinyl double hung
Acceptable Electrical: 110 VAC GFCI outlets and lighting circuits
Acceptable Counter/Cabinet: Composite and wood
Acceptable Sink/Basin: Molded single bowl
Defective Faucets/Traps: Chrome fixture with PVC trap. **Active leak at "P" trap, needs repair.**

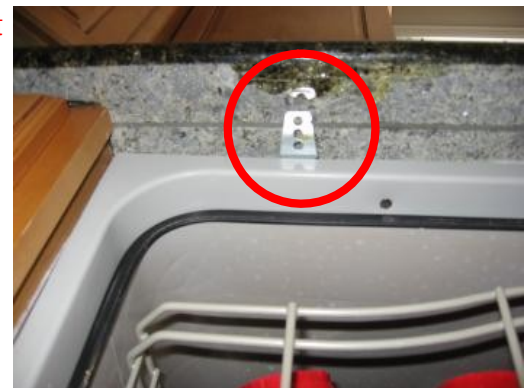
Acceptable Cooking Appliances: General Electric
Acceptable Ventilator: General Electric
Acceptable Disposal: In-Sinkerator
Defective Dishwasher: General Electric: **Dishwasher is not properly fastened to top, needs repair.**

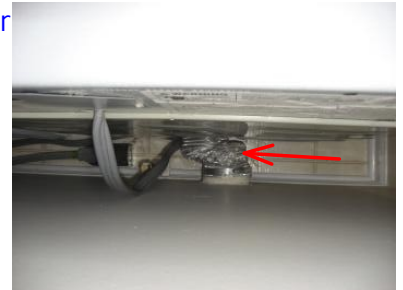
Acceptable Closet: Single
Acceptable Ceiling: Painted Drywall
Acceptable Walls: Painted Drywall
Acceptable Floor: Tile
Acceptable Doors: Solid wood
Acceptable Windows: Vinyl double hung
Acceptable Electrical: 110 VAC GFCI outlets and lighting circuits
Not Present
Acceptable HVAC Source: Heating system register
Acceptable Laundry Tub: PVC
Acceptable Laundry Tub Drain: PVC
Acceptable Washer Hose Bib: Ball valves
Acceptable Washer and Dryer Electrical: 110 VAC
Marginal Dryer Vent: Plastic flex: **Dryer vent is crushed restricting air flow, recommend repair.**
